Can One Machine Clean All Permeable Pavements?

David R. Smith¹ and Donald Rissmeyer, PE, CFM²

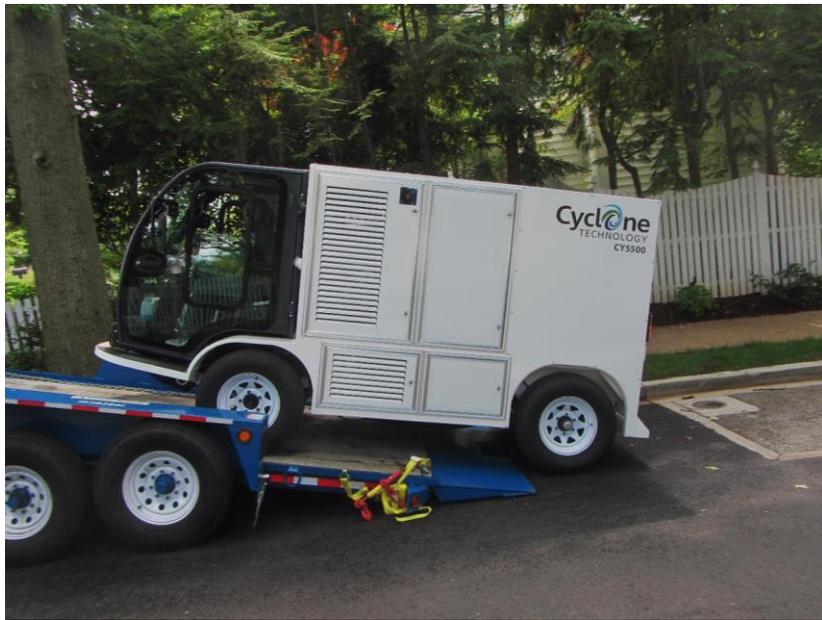
Figure 1. A Cyclone CY5500 machine used in this test experiment

The equipment used was a Cyclone CY5500 powered by a diesel engine. The machine was brought to the site on a trailer towed by a heavy-duty pickup truck. Cyclone manufactures a smaller walk-behind model and a larger truck-size version. This cleaning was done by an off-road vehicle smaller than the truck-size equipment.

The equipment was originally developed to remove tire rubber from airfield runways. This machine carries approximately 1200 liters (300 gal) of water much of which is drawn back into the machine, filtered and re-used.

The Cyclone machine relies on water applied in a circular motion within a surrounding chamber in close contact with the permeable pavement surface. The water pressure can be varied by the operator from 8 MPa (1, 200 psi) to 30 MPa (4,350 psi). The water is blasted against the pavement surface and the speed of the rotating head applying the water provides some suction (hence the cyclone name) to pull the most of the water back into the machine where it is filtered for re-use. The machine manufacturer claims cleaning rates as high as approximately 935 square meters (10,000 sf) per hour on most permeable pavements. A picture of the machine is in Figure 1 below.

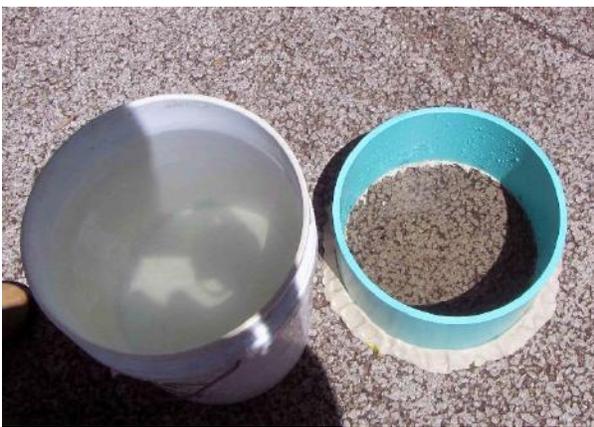
Figure 2. Initial or pre-wetting test using ASTM C1701 on pervious concrete parking lane. Note the standing water due to a clogged surface.

The four areas were cleaned in the following order: cast-in-place PC, PICP, PA, then the precast PC panel. Prior to conducting cleaning, ASTM C1701 *Standard Test Method for Infiltration Rate of In Place Pervious Concrete* and C1781 *Standard Test Method for Surface Infiltration Rate of Permeable Unit Pavement Systems* was applied to each surface. The former test method is applicable to porous concrete and both methods produce comparable results. Both ASTM test methods label the initial test procedure “pre-wetting” to determine the extent of surface clogging. This is done by applying approximately 5 kg (8 lbs) (roughly equivalent to 5 liters (1 gal)) of water into a 30 cm (12 in.) diameter ring sealed to the pavement with plumber’s putty and while maintaining an approximate head of 10 mm (3/8 in.). This is illustrated in Figures 2 through 5.

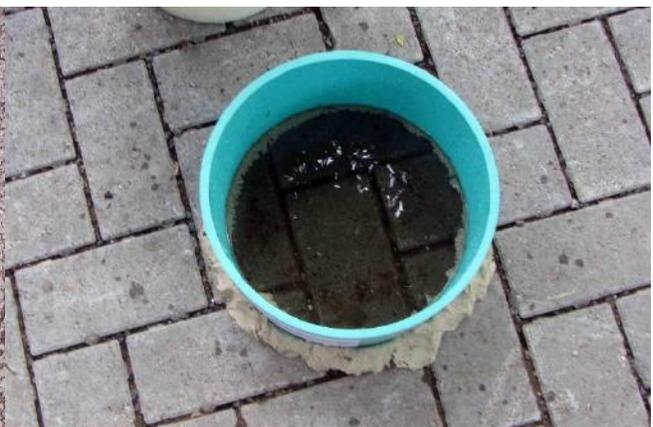
Figure 3. Initial or pre-wetting test using ASTM C1781 permeable interlocking concrete pavement alley. Standing water indicates a clogged surface.

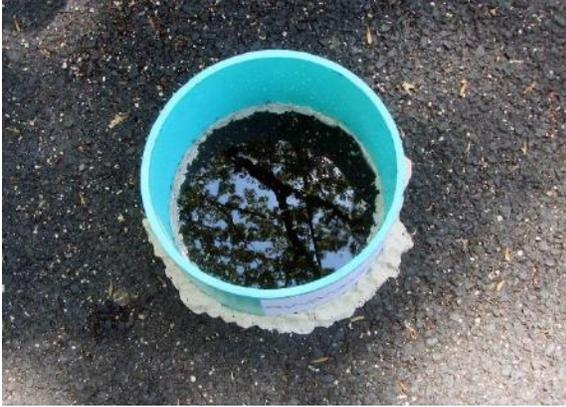
Figure 4. Initial or pre-wetting test using ASTM C1701 on porous asphalt alley. Note the standing water due to a clogged surface.

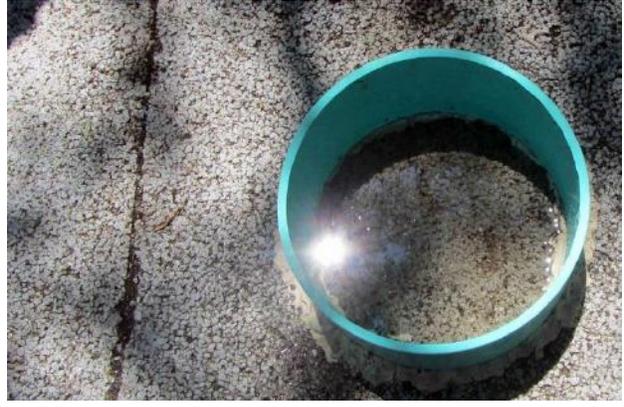
Figure 5. Initial or pre-wetting test using ASTM C1701 on pre-cast pervious concrete panel in the street parking lane. Note the standing water due to a clogged surface.

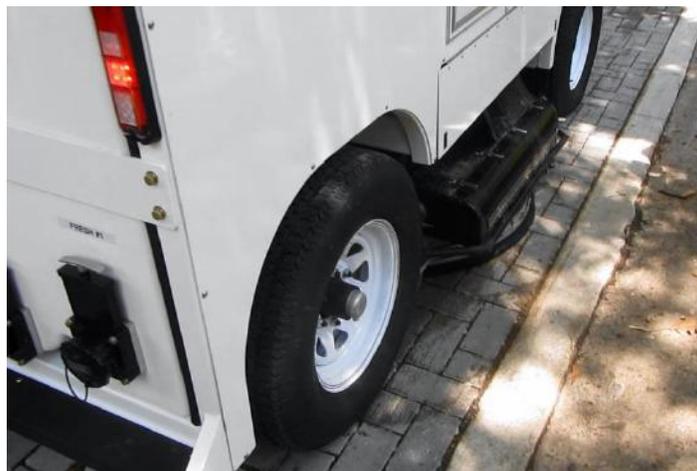
Figure 6. The Cyclone machine cleaning a PICP alley.

If the pre-wetting water applied into the ring requires more than 120 seconds to completely infiltrate, then the same amount of water (5 liters) is applied 2 minutes later. Procedures in this experiment deviated from the ASTM procedures by having the Cyclone machine pass twice over the same area of permeable pavement almost immediately after the pre-wetting was completed, requiring a few minutes of time. The pre-wetting initial infiltration test measurement was conducted to determine the extent of clogging. Figure 6 show the Cyclone machine making a typical pass of about 10 m.

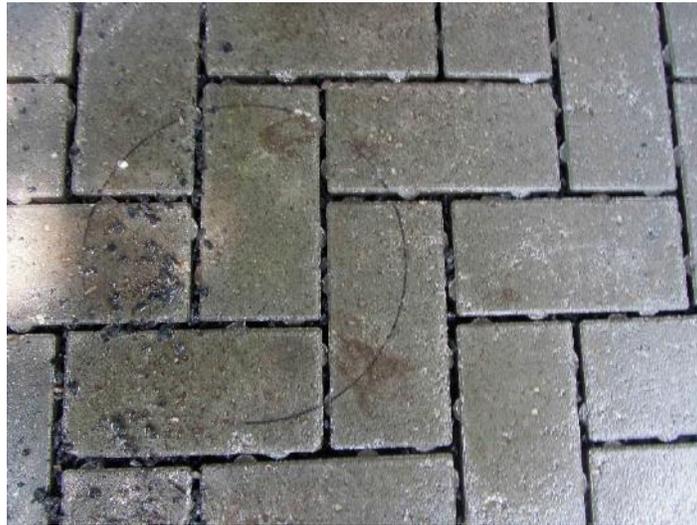
Figure 6. PICP after two passes of the Cyclone machine. Note aggregate and sediment removed resulting in open joints.

The most notable observation is that the PICP only required two passes of the Cyclone machine rather than four to increase the infiltration rate from <508 mm/hr (20 in./hr) to 8306 mm/hr (327 in./hr). The joints widths in the PICP were narrow, approximately 6 mm (1/4 in.) wide and many of the small aggregates were pulled out with the sediment after the first two passes. Some of the stones were left on the surface of the pavers after the second pass and these could be swept back into the joints. See Figure 6. Additional aggregate should probably be supplied given these results, as that is the recommendation by Eisenberg (2015) in the ASCE book, *Permeable Pavements*, Chapter 8.
